**ACCIDENT**

<b>Aircraft Type and Registration:</b>	Airwave Sport 3-L paraglider, no registration required	
<b>No &amp; Type of Engines:</b>	None	
<b>Year of Manufacture:</b>	2006	
<b>Date &amp; Time (UTC):</b>	7 September 2006 at about 1830 hrs	
<b>Location:</b>	White Rocks, near Portrush, County Antrim	
<b>Type of Flight:</b>	Private	
<b>Persons on Board:</b>	Crew - 1	Passengers - None
<b>Injuries:</b>	Crew - 1 (Fatal)	Passengers - None
<b>Nature of Damage:</b>	Minor damage to paraglider canopy	
<b>Commander's Licence:</b>	'Club Pilot (Novice)' - no CAA licence required	
<b>Commander's Age:</b>	53 years	
<b>Commander's Flying Experience:</b>	Approximately 100 hrs	
<b>Information Source:</b>	AAIB Field Investigation

**Synopsis**

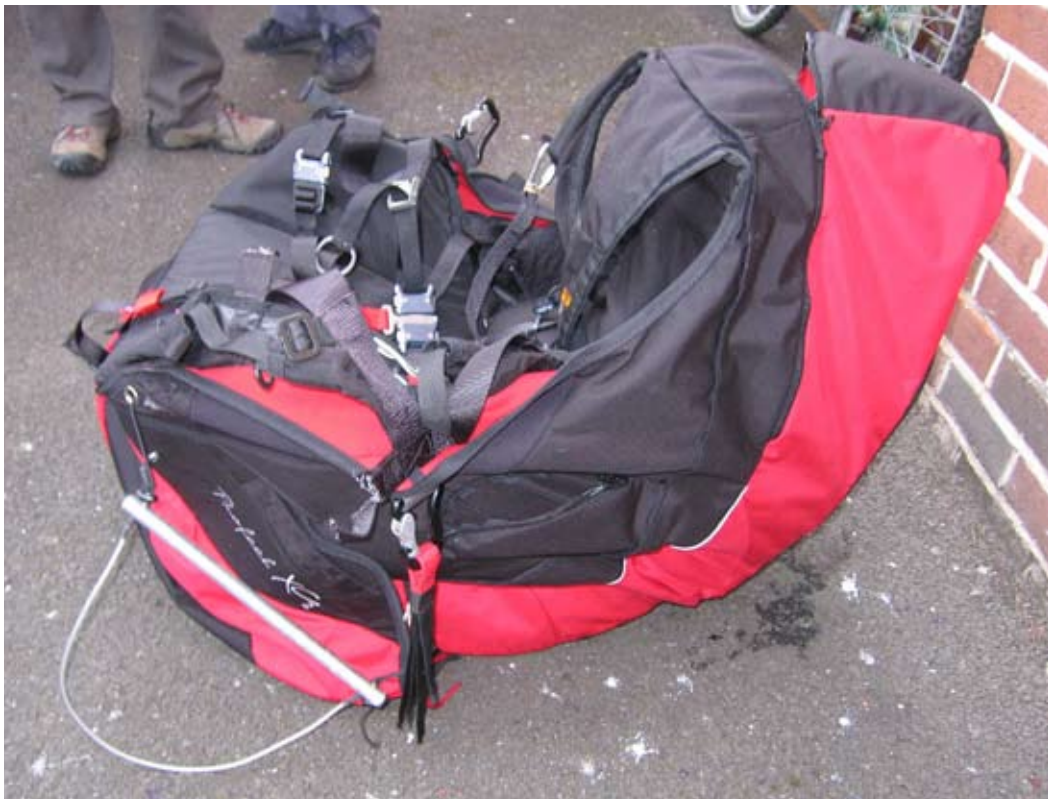
**Figure 1**

The Profeel XC2 harness, (Figure 1), was fitted with shoulder, lap and leg straps to secure the pilot. The shoulder straps were attached to the lap straps and both the lap and leg straps were fastened using quick release latches, which could be released by simultaneously pressing two tabs on the latch. A reserve parachute was carried in a pocket on the lower right side of the harness and an additional pocket was provided on the rear of the harness to allow stowage of personal items. The harness incorporated a 'Bumpair 17' back protection system, which was designed to provide cushioning in the event of a hard landing. The 'Bumpair 17' consists of a 40-litre multi-cell shaped foam 'cushion' extending from the pilots shoulders around the base of the harness and under the pilot's thighs, reaching its maximum thickness at the base of the spine and under the pilot's thighs. The foam is designed to release air and compress at a controlled rate, to minimise shock loading of the spine and legs.

Profeel XC2 harness

The harness showed no defects which would have contributed to the accident, or which would have prevented the pilot releasing himself from the harness whilst in the water.

The harness lap and leg straps would have made swimming difficult and would have hampered the pilot's attempts to climb onto the submerged rocks. The buoyancy from the Bumpair air bag in the harness would also have tended to push the pilot's head underwater, this being compounded by the pilot's lack of a life jacket. These facts, together with the sea state presented by the spring tide and prevailing weather, resulted in a set of circumstances that significantly increased the likelihood of drowning.
