**British Hang Gliding and Paragliding Association**

# **REPORT**

**Investigation of a paragliding accident which occurred at the Long Mynd, Shropshire, on the 8<sup>th</sup> August 2009 which resulted in the death of one pilot and serious injury to the other who died nine days later.**

BHPA investigation serial number: IR 09/065

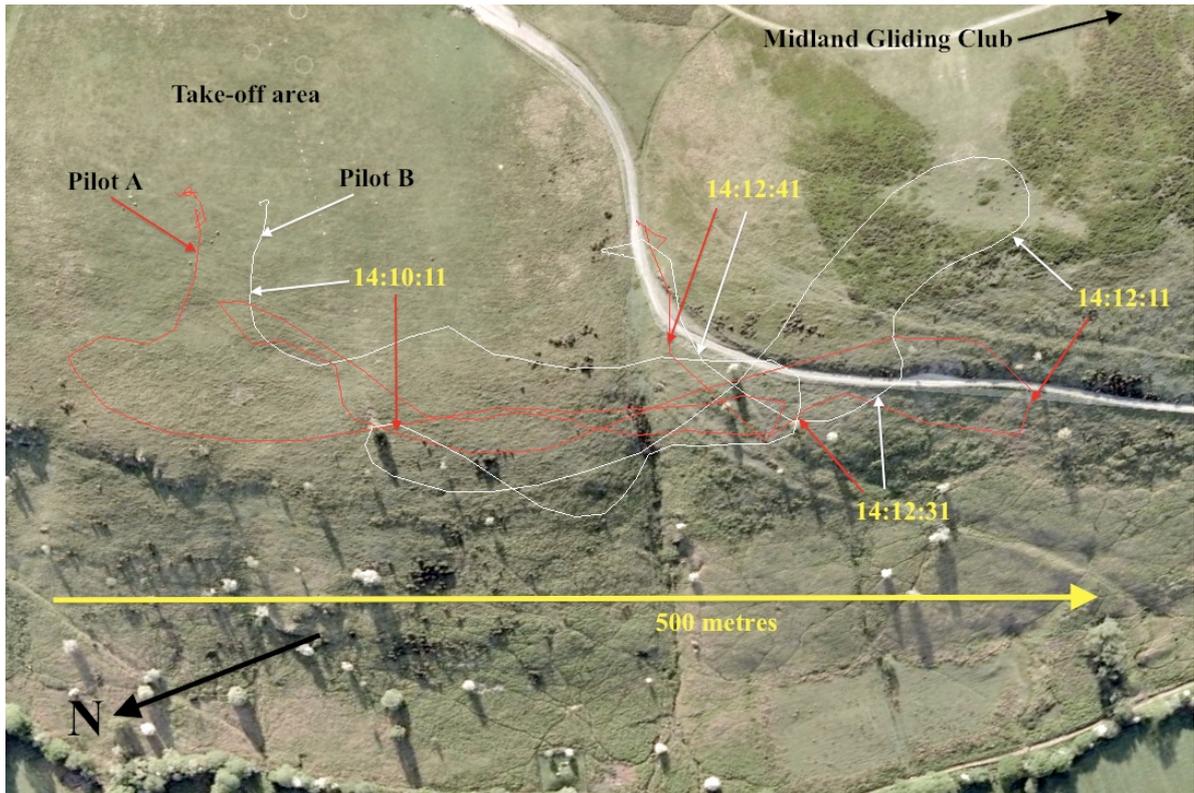
‘Pilot A’ took off at 2.09pm shortly followed (within a minute) by ‘Pilot B’. Both pilots began to beat back and forth along the front of the hill in an attempt to gain height (see Photo 1, below).

Photo 1, showing the flight paths of Pilots A and B and their positions at points in time.

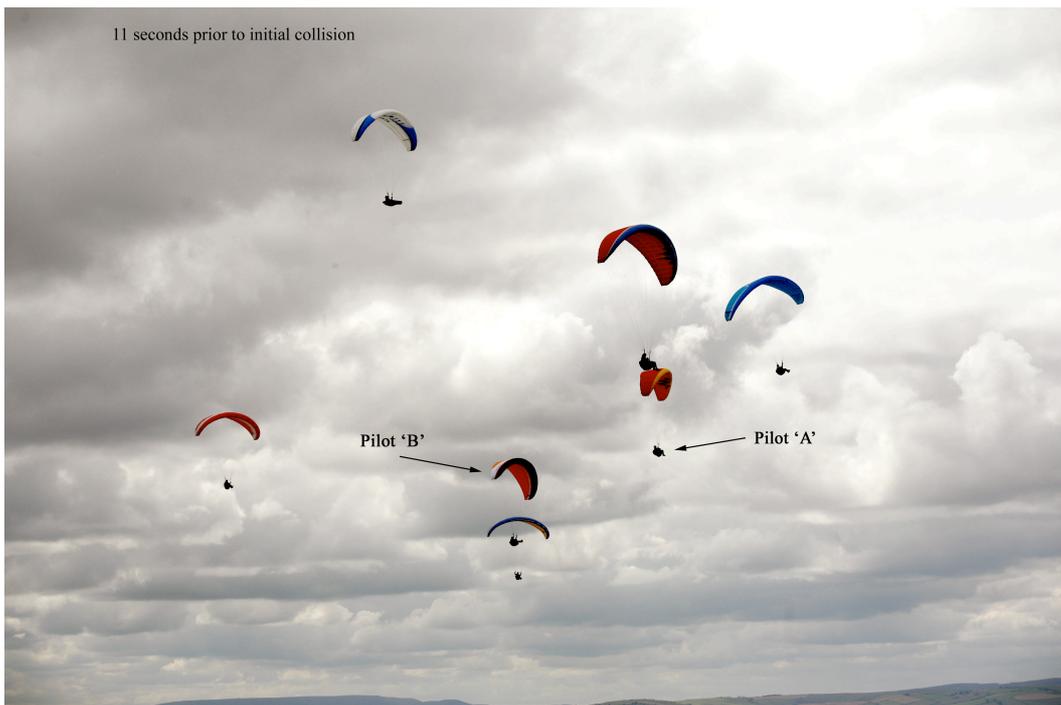
Three minutes after taking off, both 'Pilot A' and 'Pilot B' were flying in a north-easterly direction back towards the take off area. They were in a group made up of approximately seven paragliders (see Photo 2, below).

Photo 2, showing position of Pilots A and B, 11 seconds prior to collision.

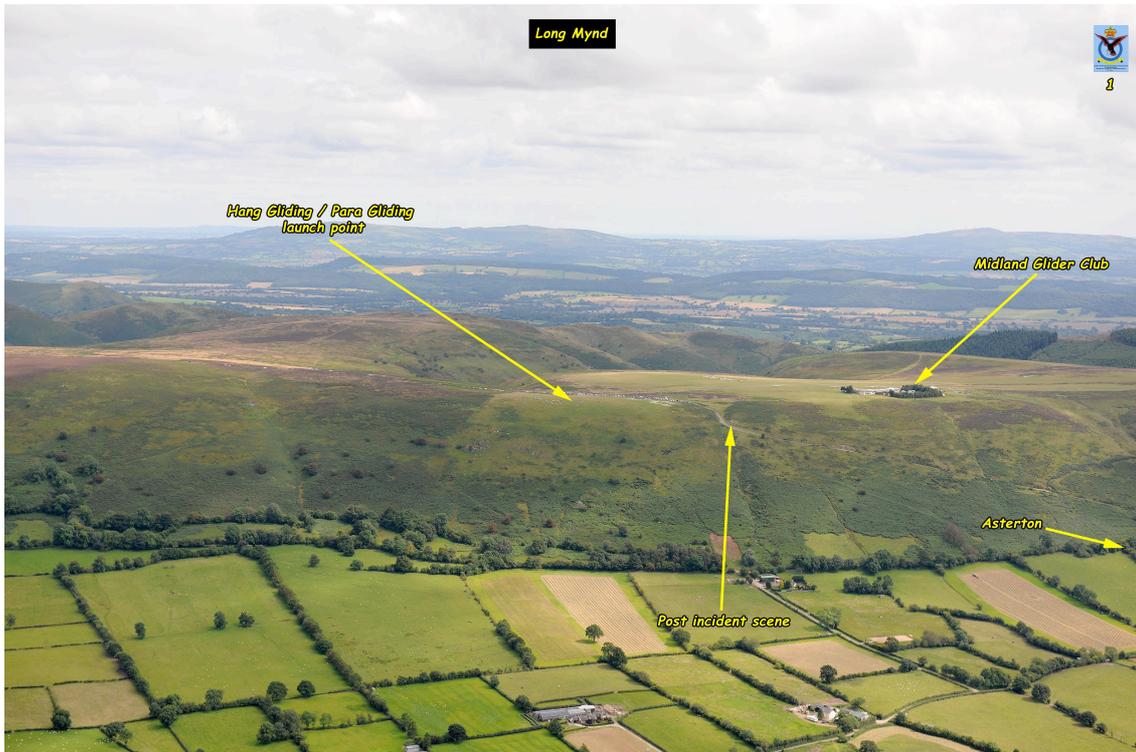
Photo 3, showing a section of the Long Mynd, take-off area and incident site.

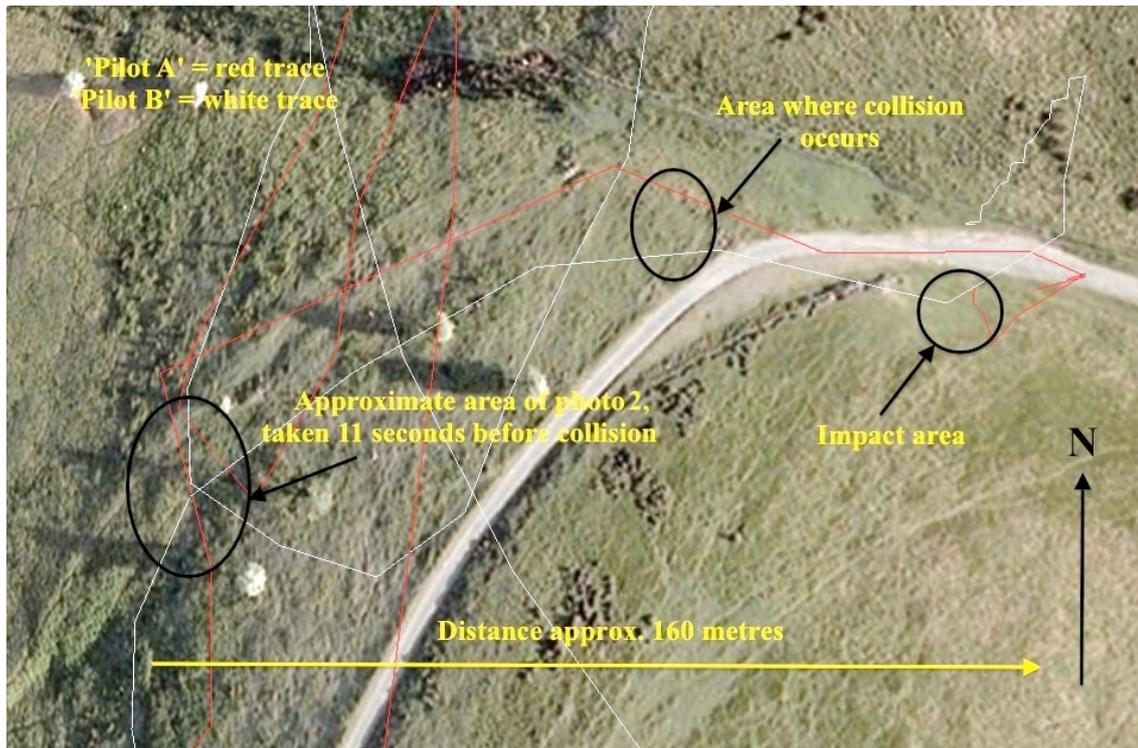
'Pilot A' took off at 14:09:00 (all times are BST). He flew away from the hill then briefly north before heading south down the ridge. 'Pilot B' took off at 14:09:50, flew away from the hill and then turned left in a southerly direction. The two pilots continued to beat back and forth along the ridge (see Photo 1.) until at 11 seconds before the collision where they were in the positions shown in Photo 2 and highlighted in Photo 4, below. Approximately 10 seconds later having been in the air for between three and four minutes and while on a north-easterly track, at between 14:12:41 and 14:12:50, the two pilots collided and became entangled with each other (see Photo 4, Below). While on the north-easterly track, in the moments leading up to the collision, Pilots A and B were no more than twenty metres apart.

Photo 4, showing the collision and impact areas and also the approximate location of Photo 2.

The pilots impacted approximately 170m south of the take off area and adjacent to the access road that comes up and bisects the hill. This area is grassy and sloping, however, in this immediate area there is only a shallow layer of soil covering the underlying rock making it extremely hard. (See photos 1 and 4)
