**Investigation of a hang gliding accident
which occurred at Clatter, Mid Wales,
on 27th June 2010
in which one pilot suffered serious injury.**

BHPA investigation serial number: IR 10/060

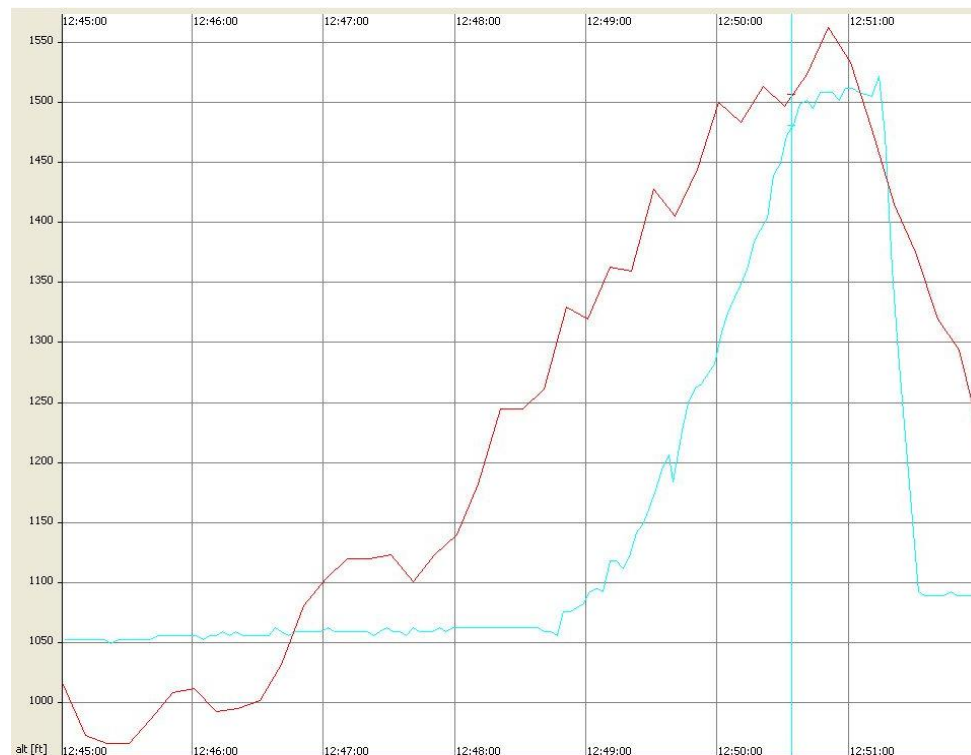
Pilot B did not see Pilot A during the five climbing circles of his climb. This may have been due to the fact that Pilot A was higher than him and it is possible that Pilot A was masked by his wing. Pilot B's average climb rate was approximately 1.5m/s (300fpm) so it is unlikely that extreme bank angles were being used.

Pilot A did have Pilot B in view during much of the sequence, but adjudged that he was at a safe distance. Pilot A then seems to have been caught out by their rapidly changing positions and heights. Pilot A was in weaker lift fractionally downwind of the core of the thermal – whilst Pilot B was in stronger lift in the core. At 12:50 Pilot A was 200 feet higher than Pilot B. Thirty seconds later they collided. During some of the 180 degrees of turn before the collision, Pilot A's wing would have masked his view of Pilot B. And they would have had a closing speed of approximately 60mph.

Barograph traces for the two pilots. Red trace = Pilot A, Blue trace = Pilot B
